Damage Survey and Assessment of Fort Worth Tornado, 28 March 2000

Prepared By
C.W. Letchford, H.S. Norville, and J. Bilello
Wind Science & Engineering Program
Texas Tech University

Submitted to
National Institute for Standards and Technology
August 2000

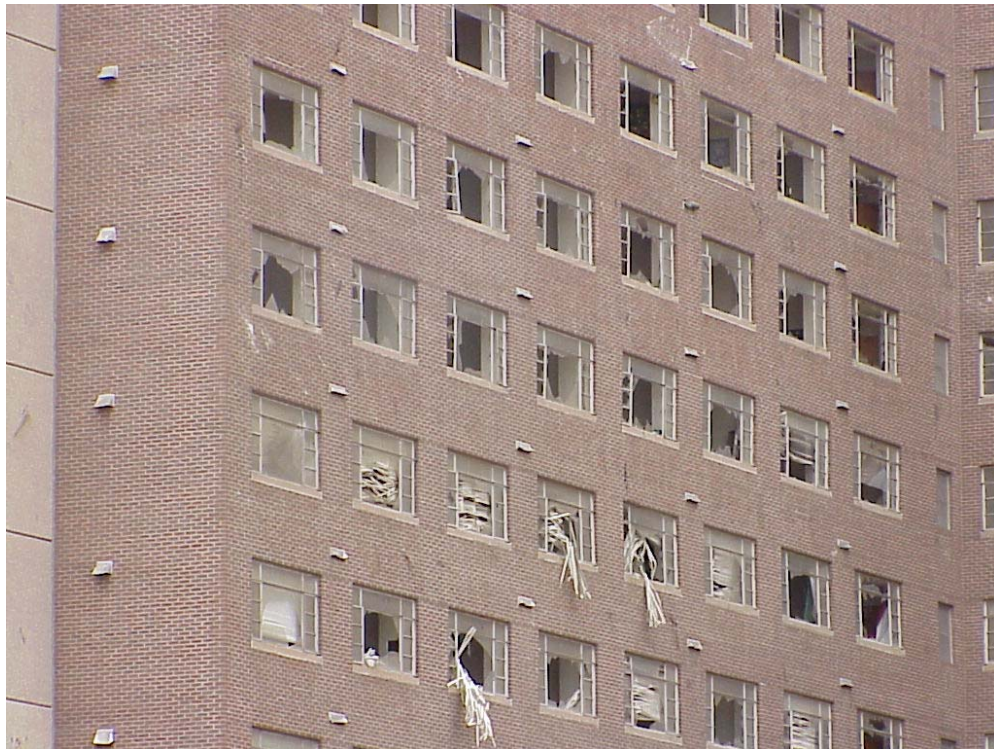
Hunter Plaza, a twelve-story accommodation building, U-shaped in plan, appeared to suffer window damage to all faces and all levels. Here the glazing was only 1/8" single pane, while Insulating Glass (IG) units on the adjacent INSpire Insurance building, made up of two $\frac{1}{4}$ " panes separated by $\frac{1}{2}$ ", suffered breakage of outer panes only. This

Figure A.24 Window breakage at Hunter Plaza, south facing interior of U-shaped plan.

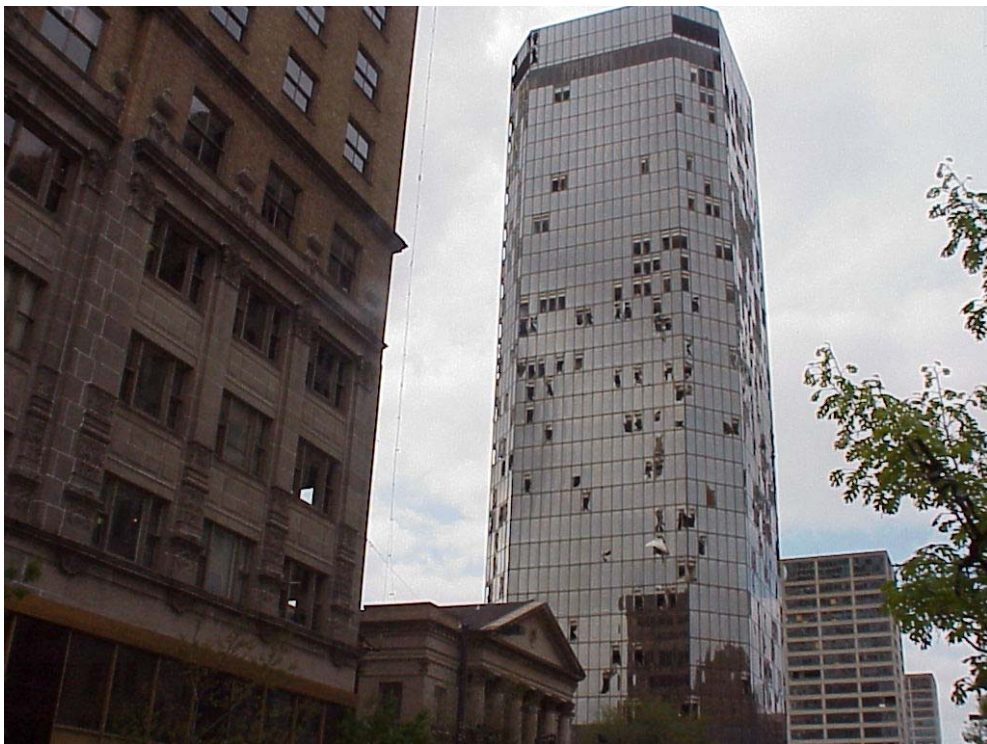
Bank One is a chamfered square in plan-form with the chamfers being approximately one-quarter of the side length of the enclosing square. The northwest face (~60% broken), southwest face (~90% broken) and the intervening west chamfer (~100% broken), sustained heavy impact damage. The northeast face had about one-half the number of breakages on the southwest face, while the southeast face received approximately one-eighth of the southwest face. The intervening chamfers had intermediate numbers of breakages and these tended to be concentrated along the corners, indicating that they may have failed under internal pressurization. Interestingly, the internal partitions around the lift core appeared to withstand these pressure gradients. This was most noticeable on the top floor restaurant level where there was significant window failure around the entire floor level. Access to corner offices was not possible to confirm whether this was typical for all partition walls.

Figure A26. Southeast face of Bank One building.

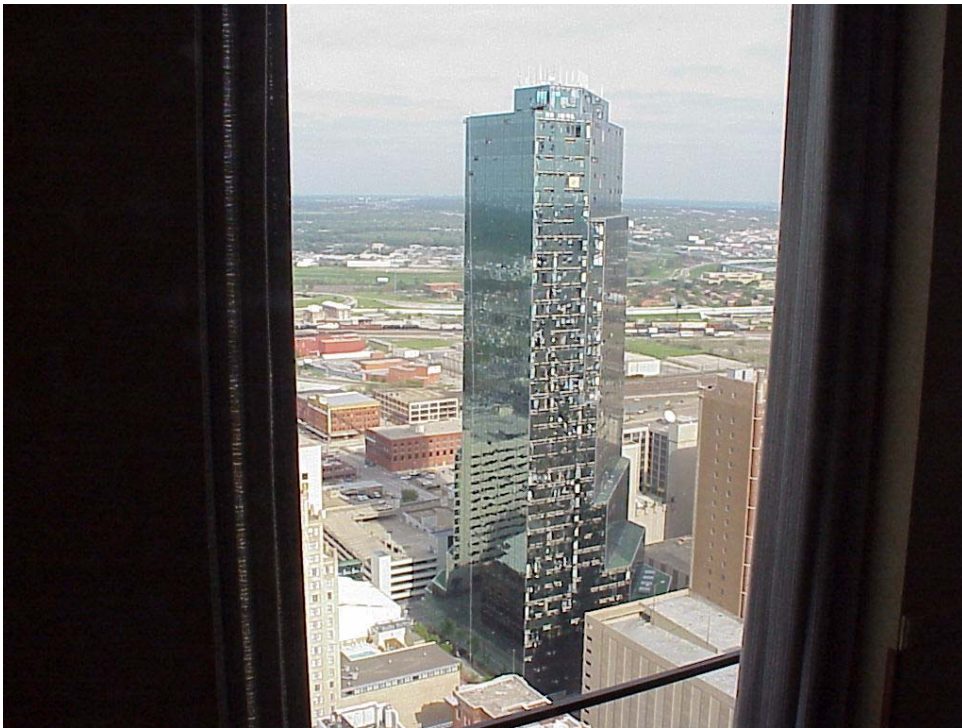
The Union Pacific Resources Tower (UPR), located approximately one-fifth mile to the east of Bank One Tower suffered the heaviest impact damage to its southwest and south faces, with hardly any damage to the other faces. Corner windows appear over-representative for pure impact damage and indicate that internal pressurization may have lead to outward failure of these windows. The Bank One Tower is likely to have been a primary source of debris for this building.

Figure A28. Southwest face of UPR Tower from Bank One
